Surface Contamination Test Results

Collected by George Henderson

Air Restore U.S.A.

Air Naturalizer

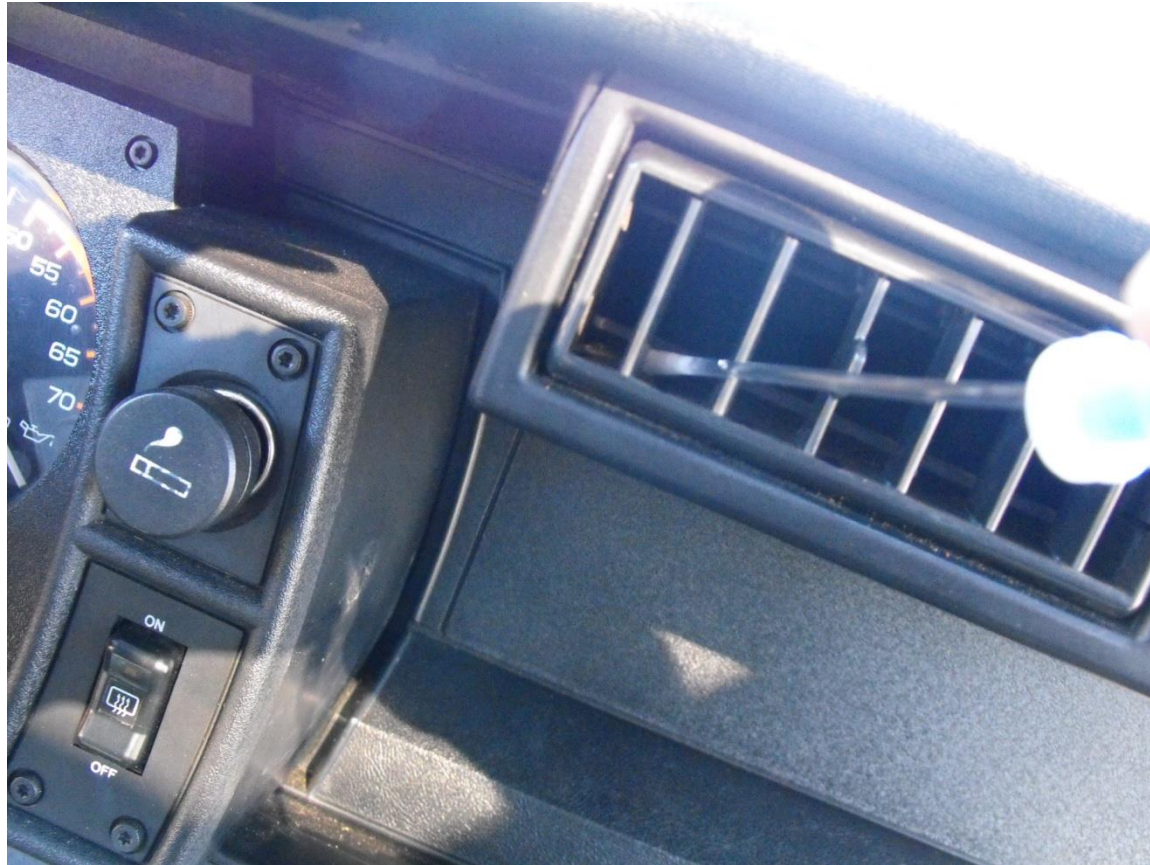
Collection of sample to determine contamination

Initial sample collected inside A/C vent. Before treatment

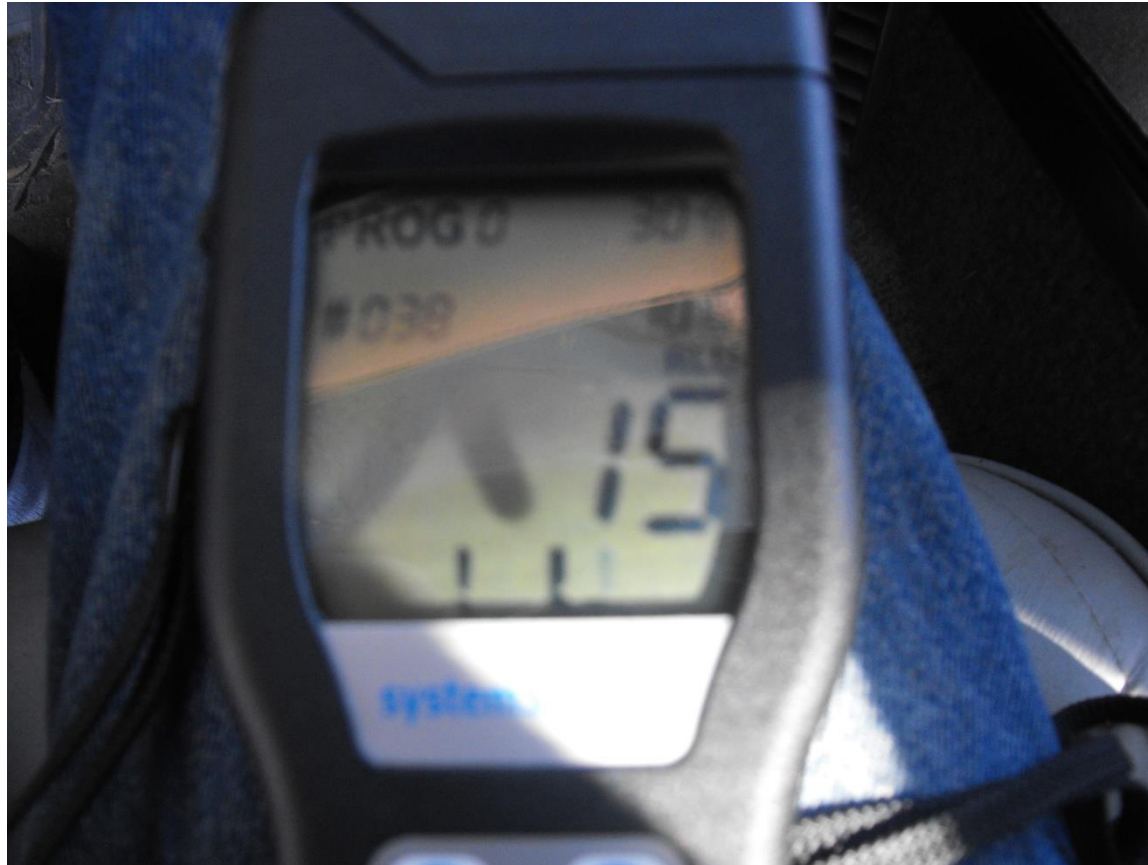
Contamination count 15

System Sure instrument designed to analyze the UltraSnap ATP swab.

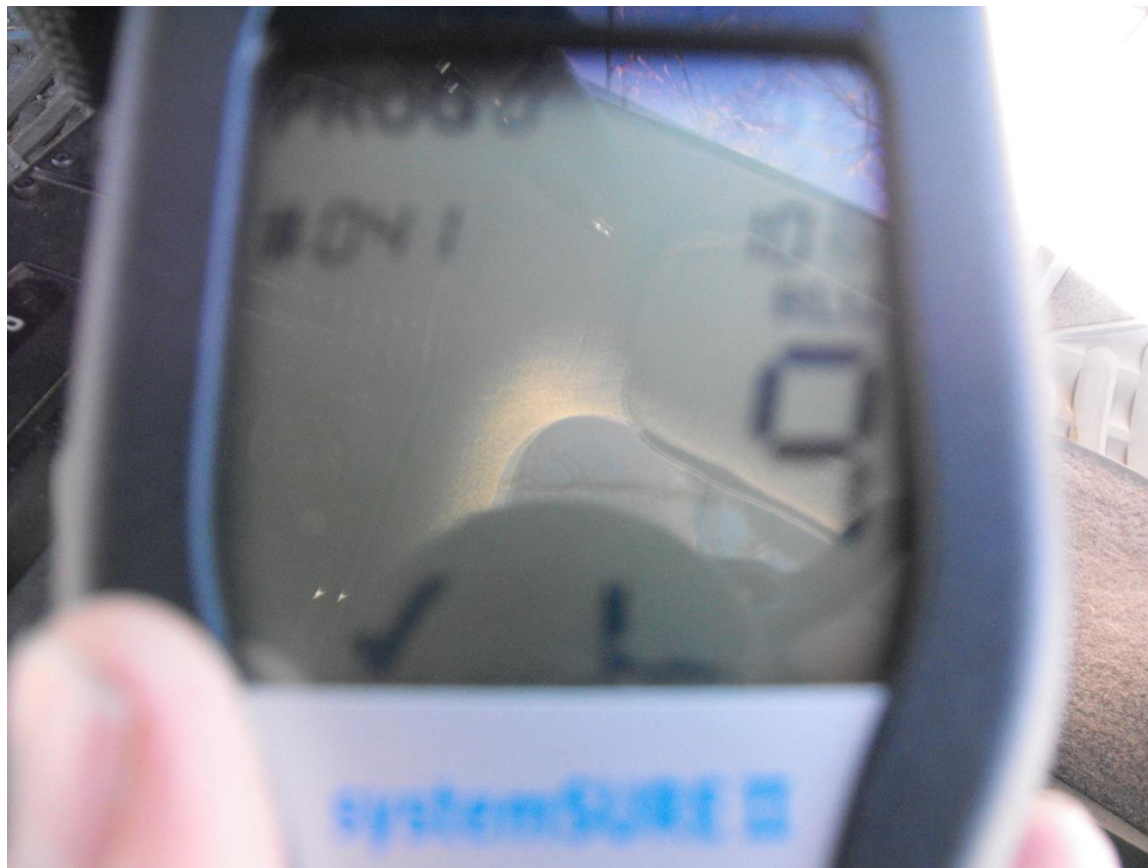
Contamination Count 09

Total contamination from 3 different locations.

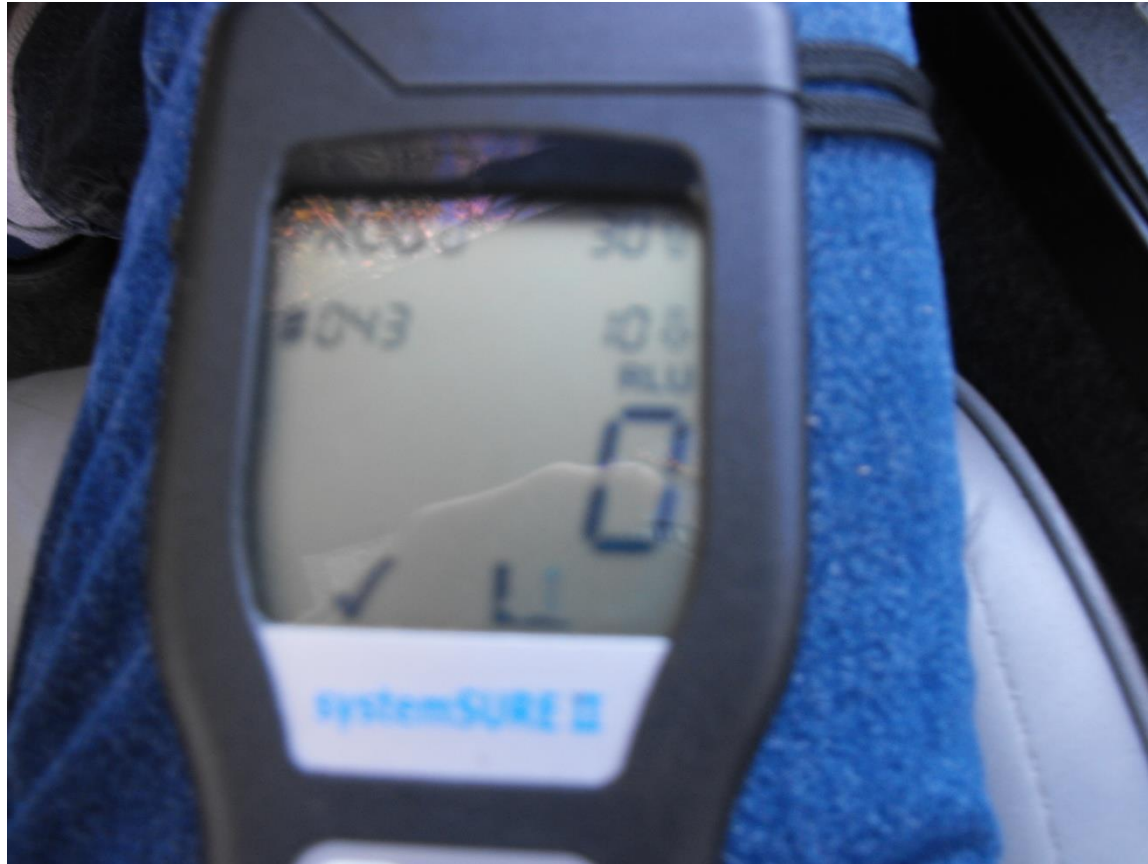
Contamination Count Zero

No ATP detected in sample. Original sample reading was 15.

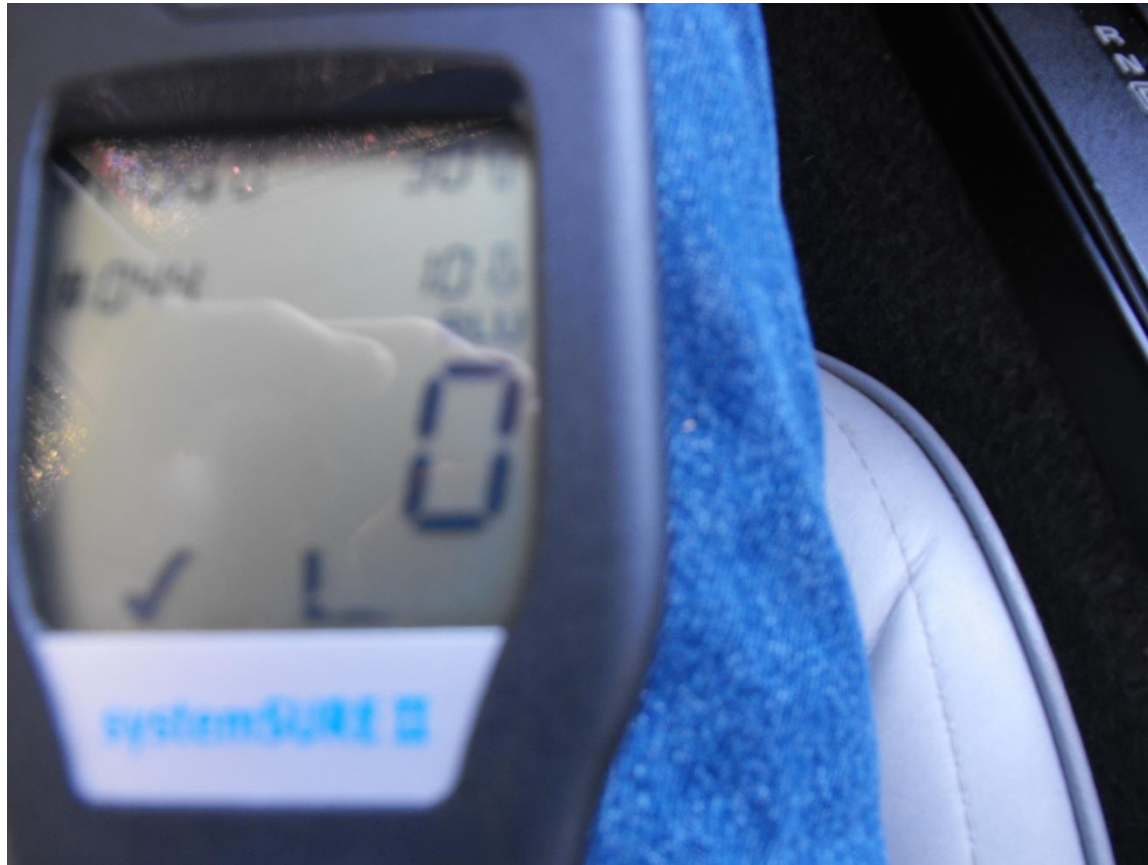
Contamination Count Zero

Total ATP detected in swab from all dash collection sites. Original sample reading was 09.

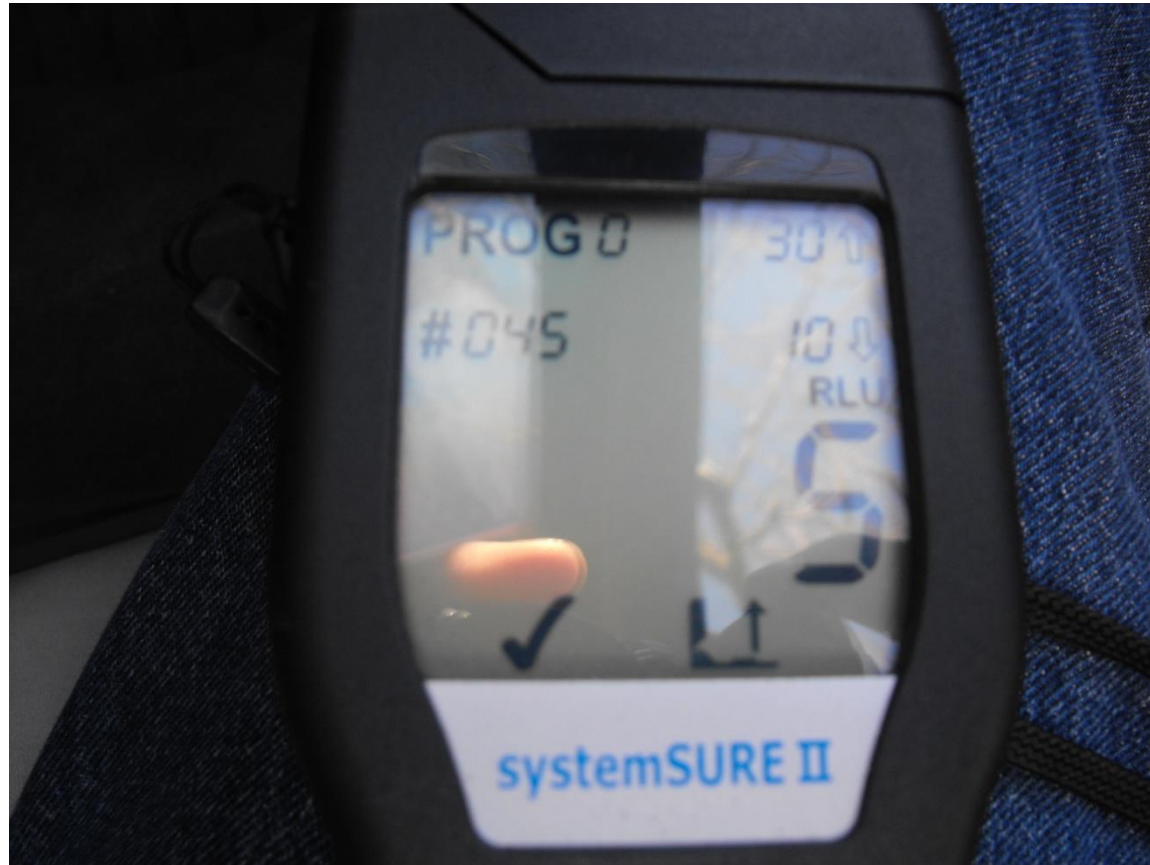
Contamination Count 05

Total ATP detected from all random surface samples collected after area exposed to Air Naturalizer for 16 hours.

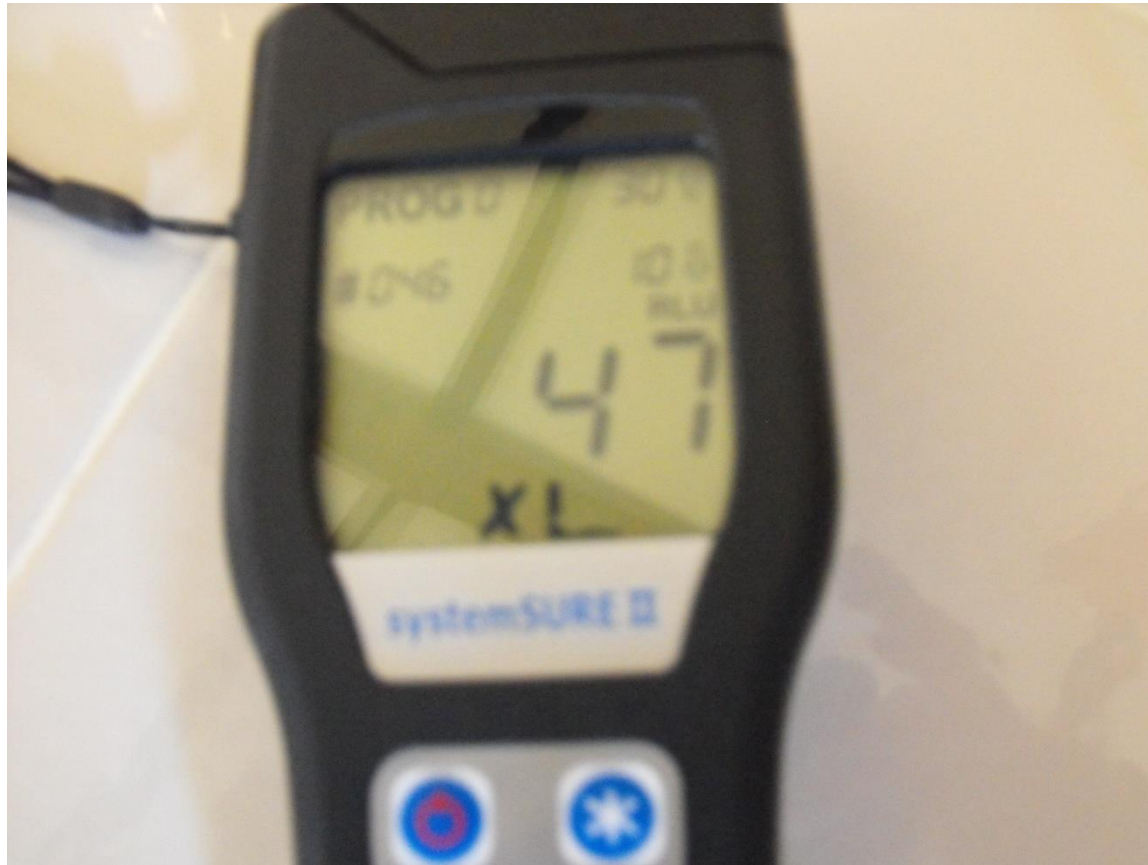
Contamination Count 47

Amount of ATP detected in grill sample.

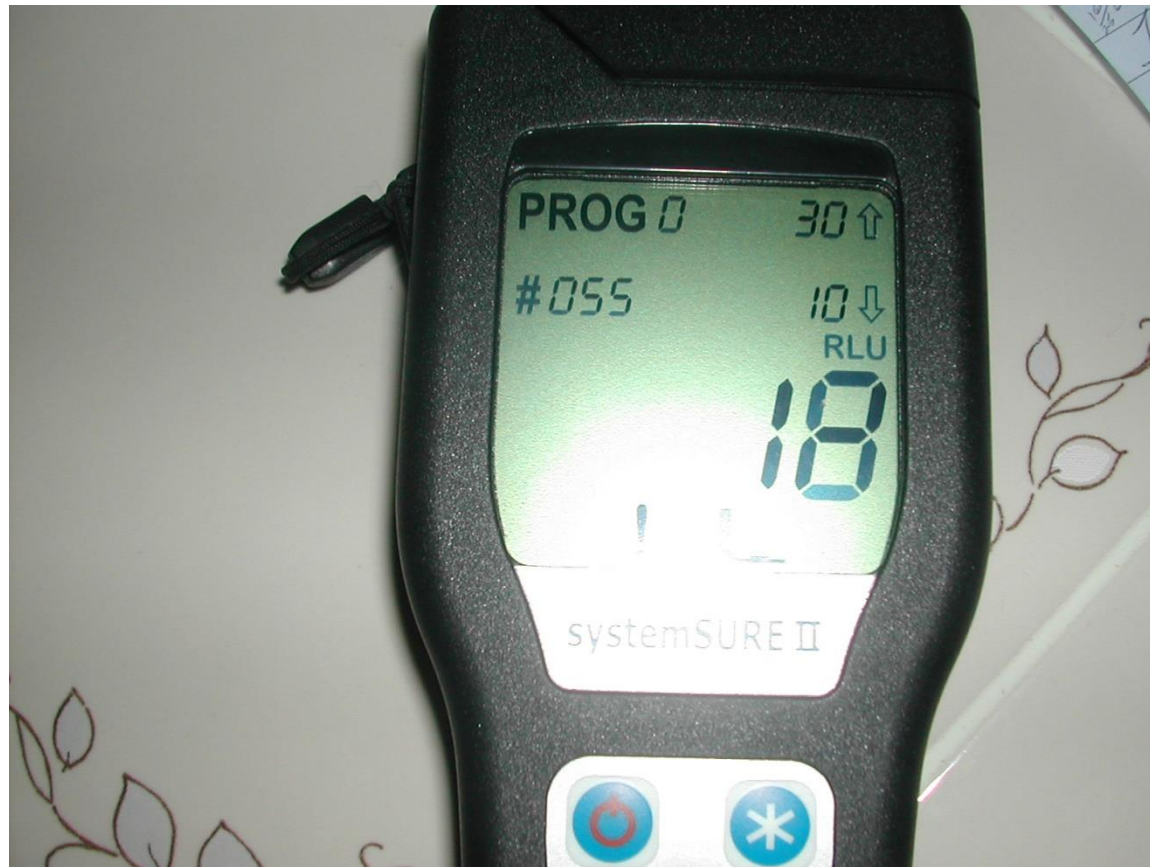
Contamination Count 18

Initial contamination count from A/C grill was 47. After 7 days count was 18.

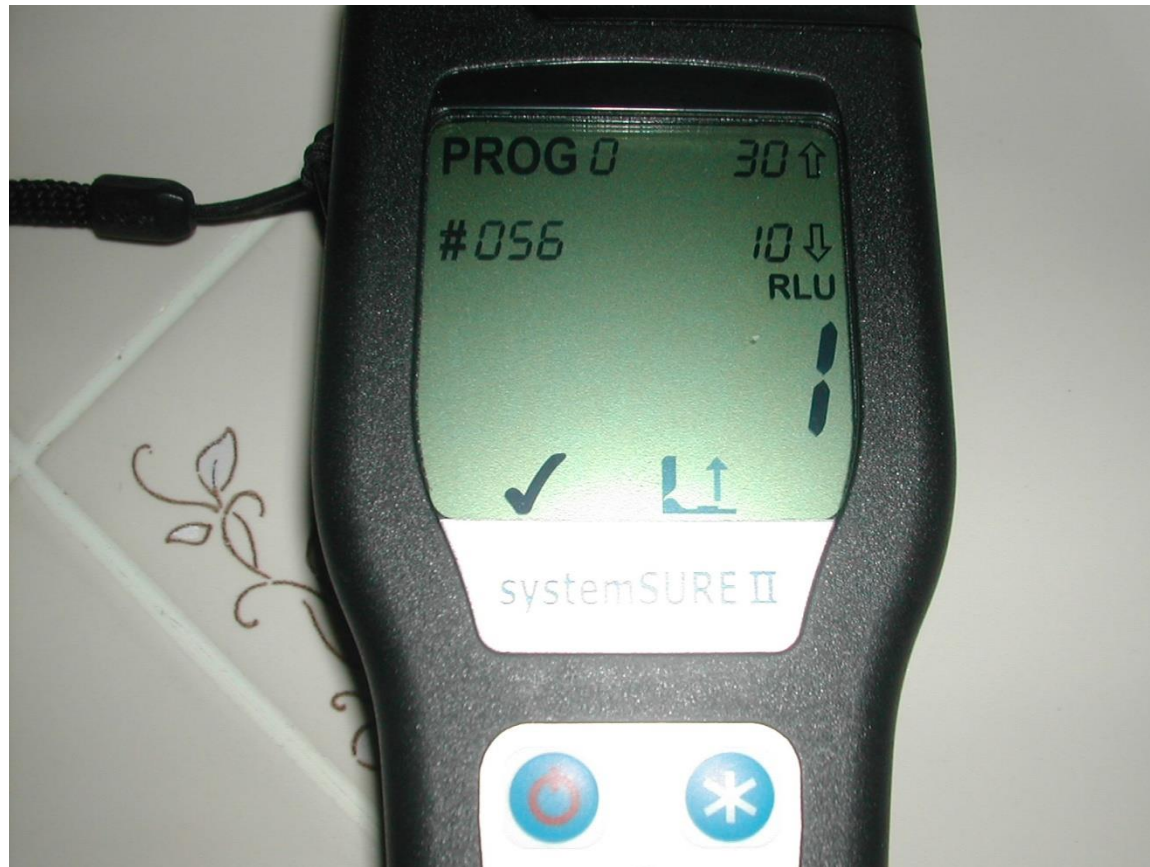
Contamination Count 01

Initial contamination count from ledge in master bathroom was 136.
After 7 days cont was 01.

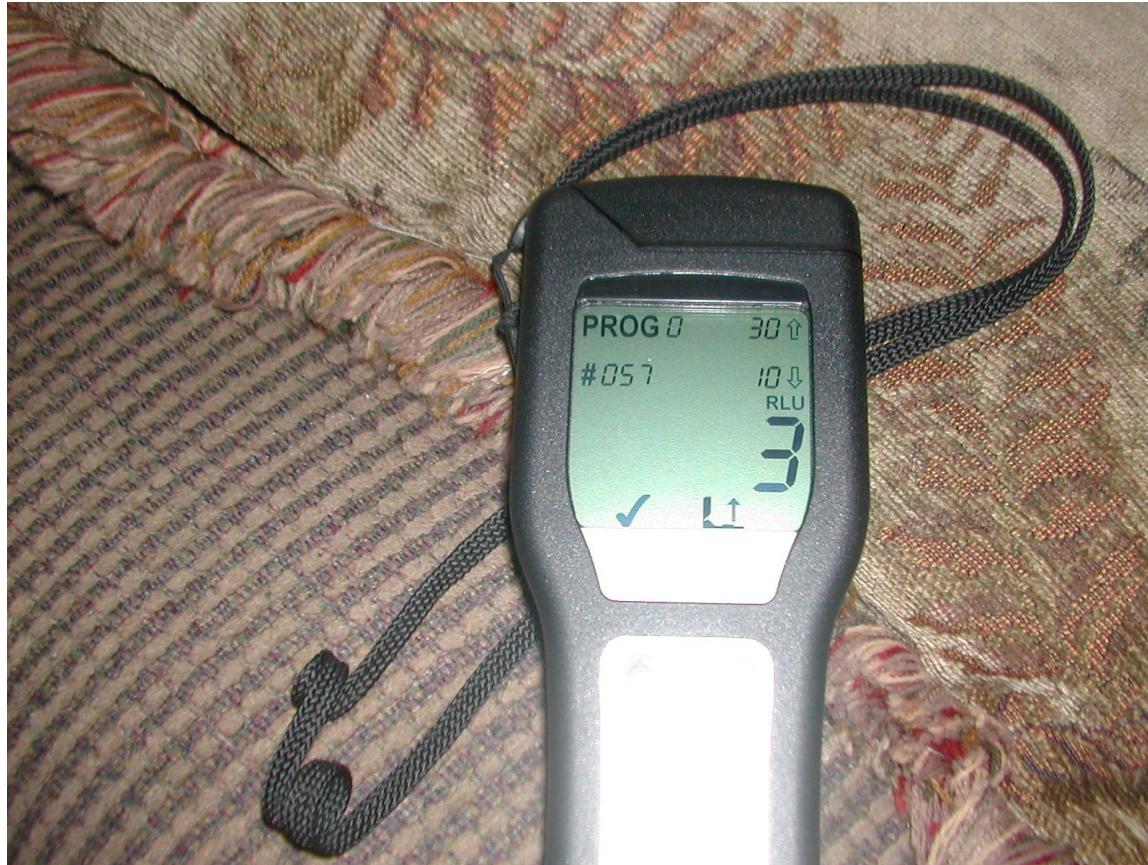
Contamination Count 03

Initial count from mirror on wall in living room was 207. after 7 days count was 03.

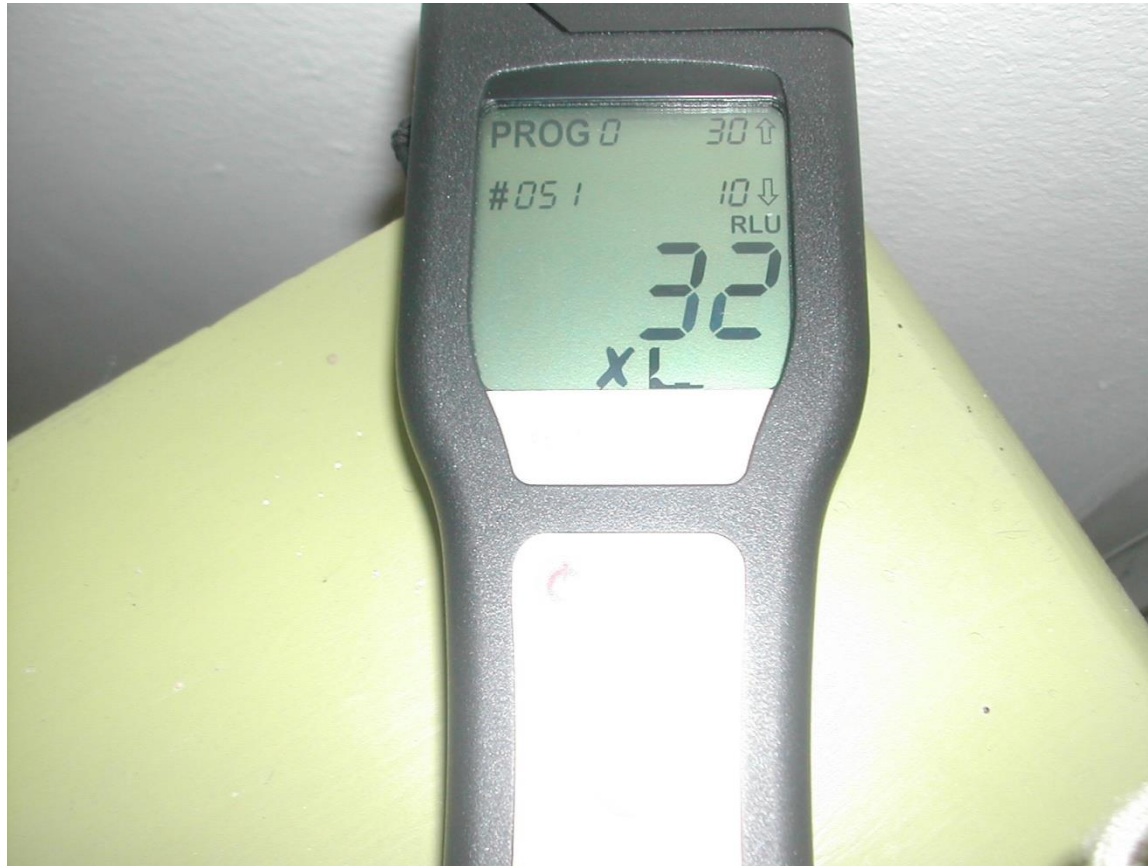
Contamination Count 32

Initial count of ATP collected on surface of night stand.

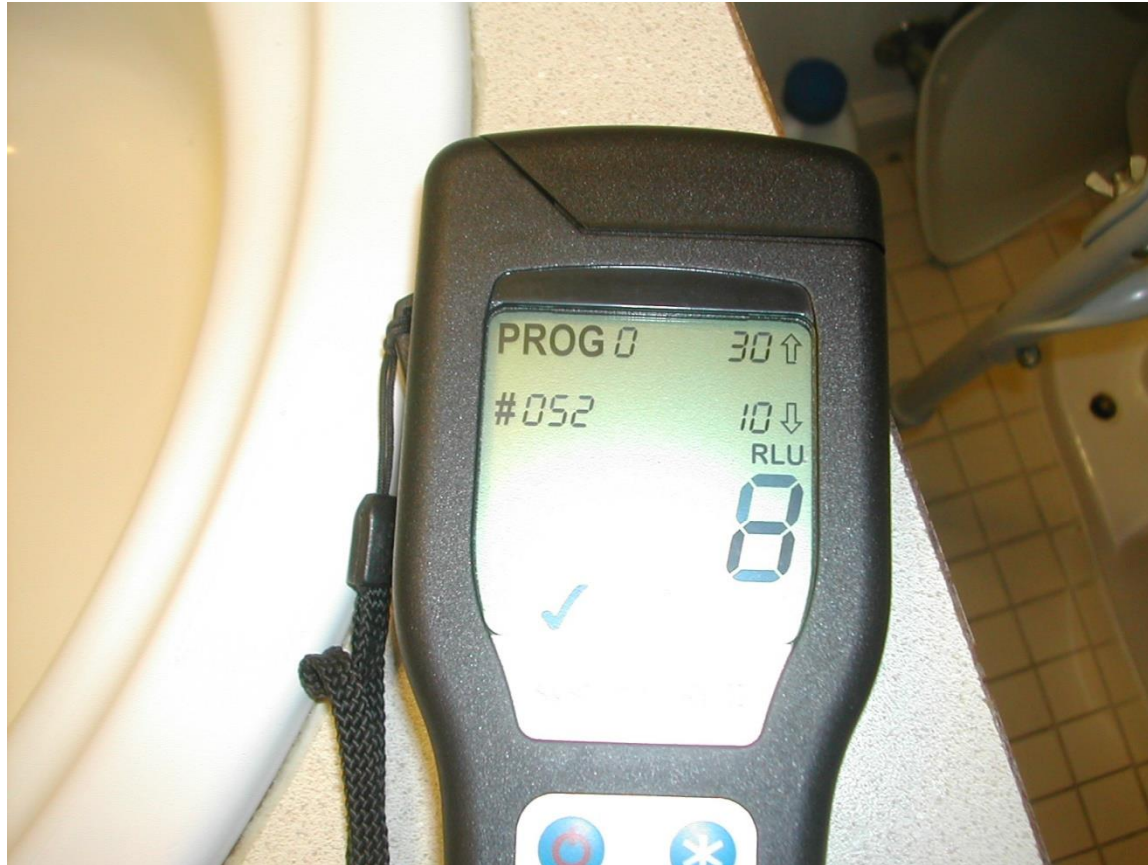
Contamination Count 08

Initial count of ATP collected in surface sample from top of paper towel dispenser.

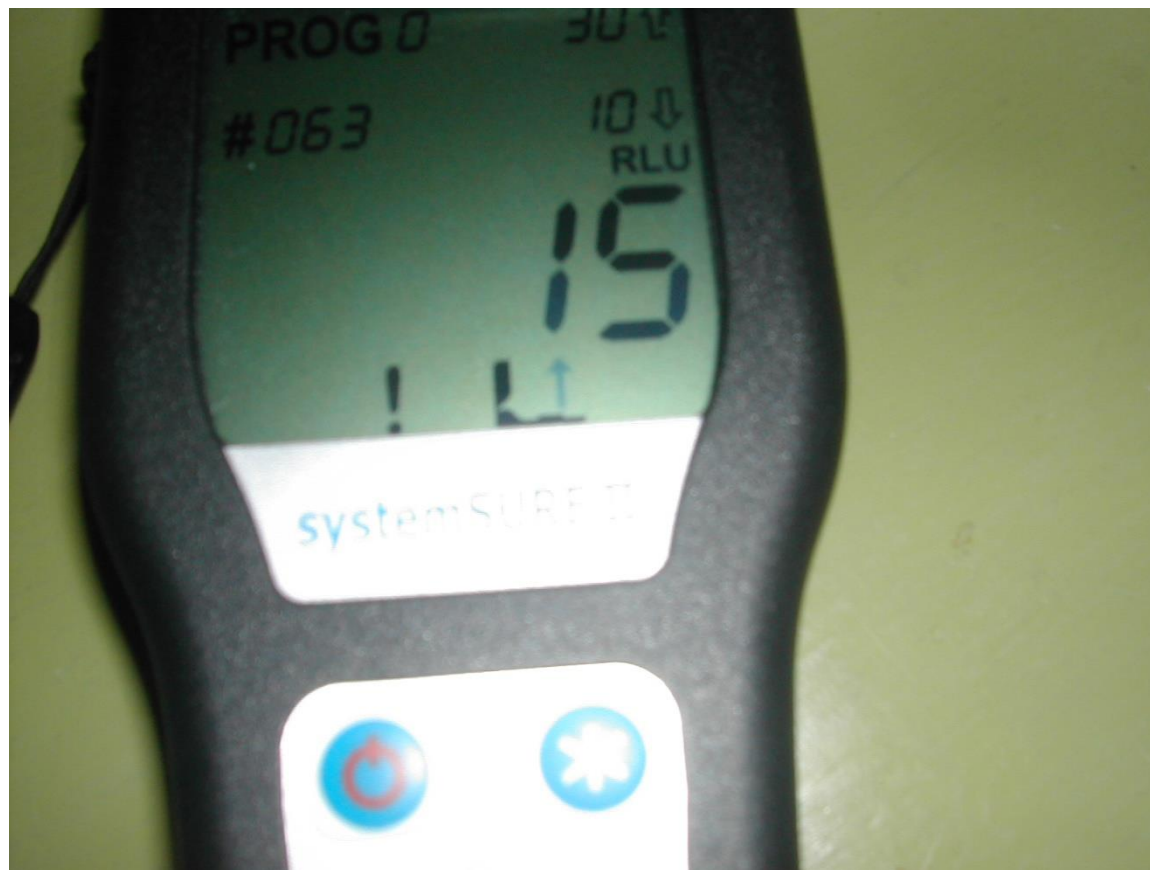
Contamination Count 15

Initial contamination count from top of night stand next to bed was 32.
After 5 days count was 15.

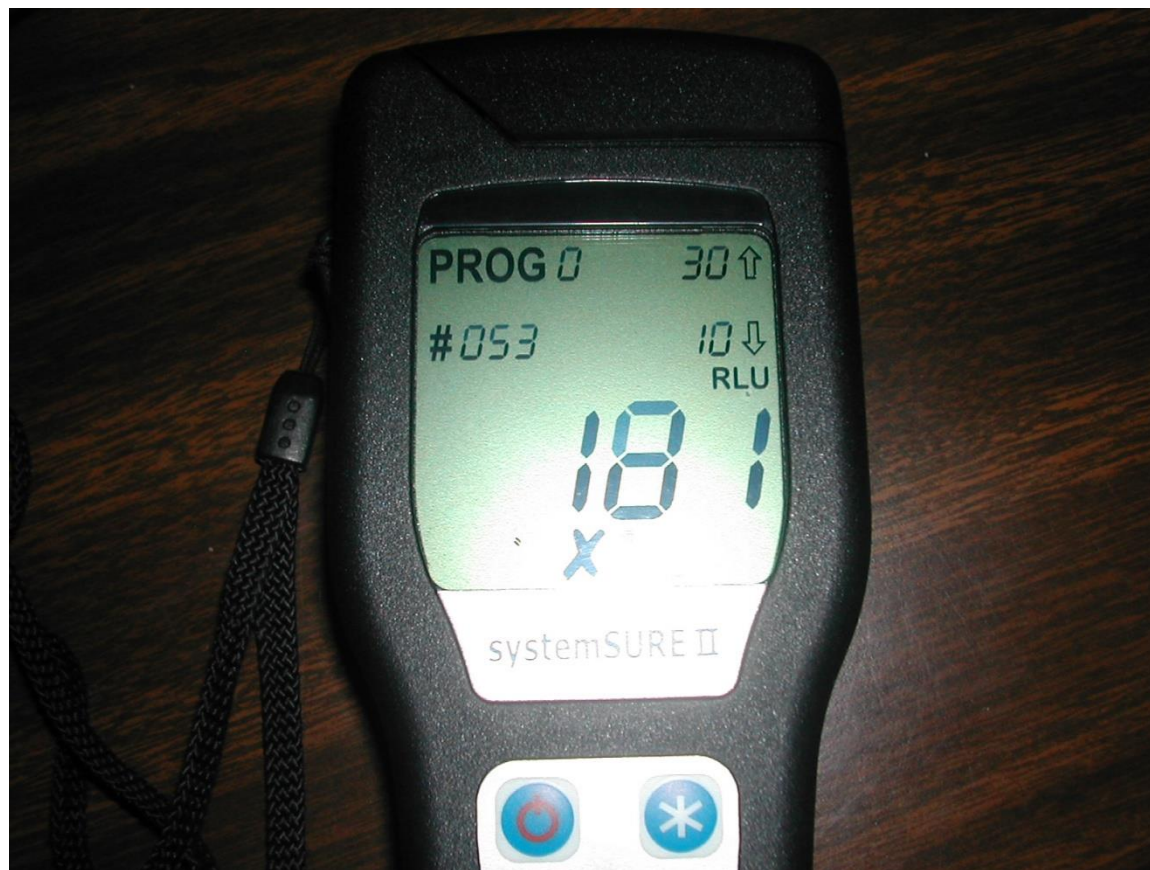
Contamination Count 181

Initial count of ATP collected in surface sample from top of file cabinet.

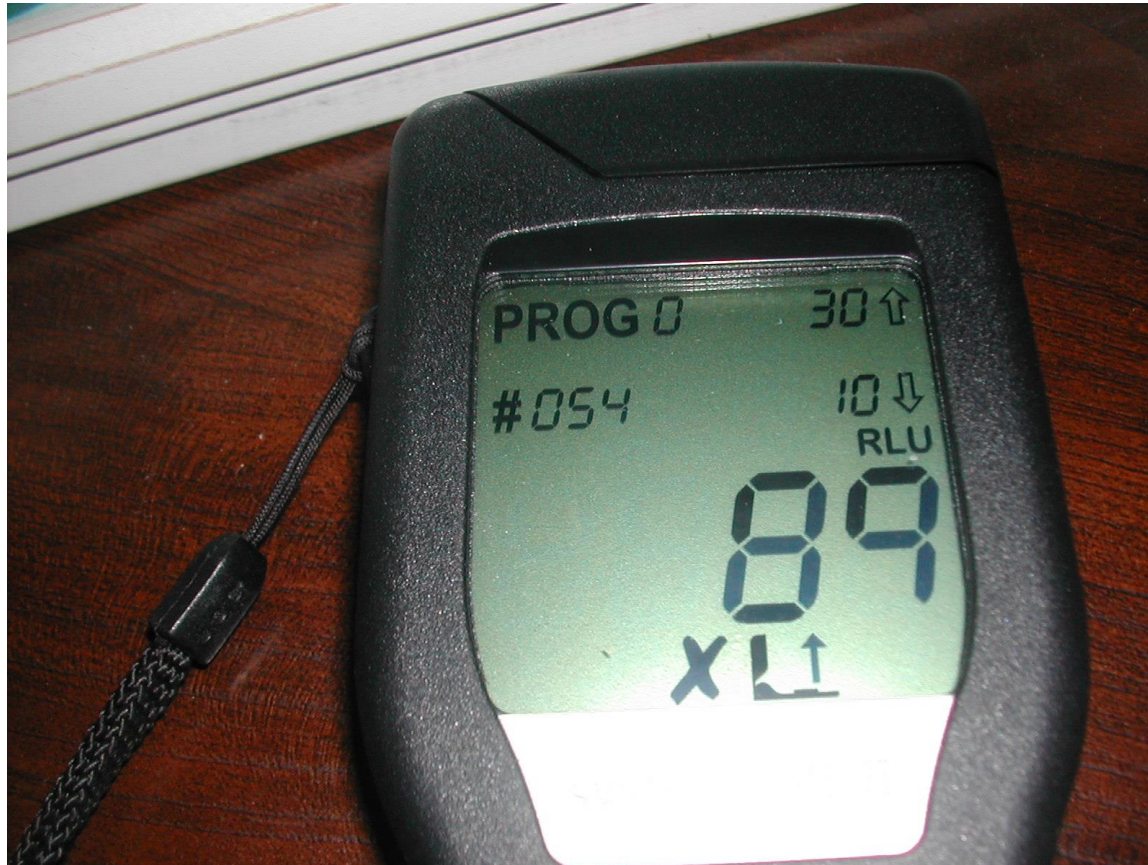
Contamination Count 89

Initial count of ATP in surface sample collected from top of dresser in bedroom.

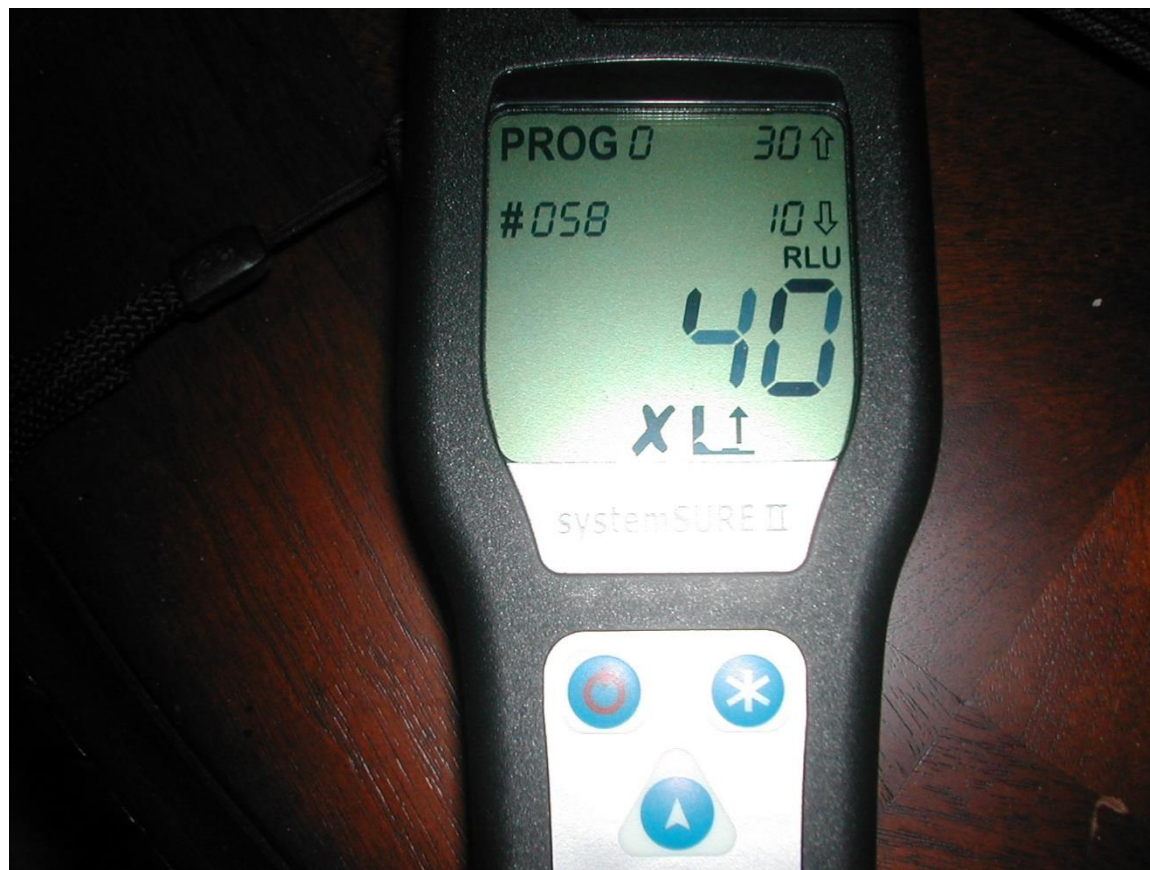
Contamination Count 40

Initial count from top of file cabinet was 181. After 9 days count was 40.

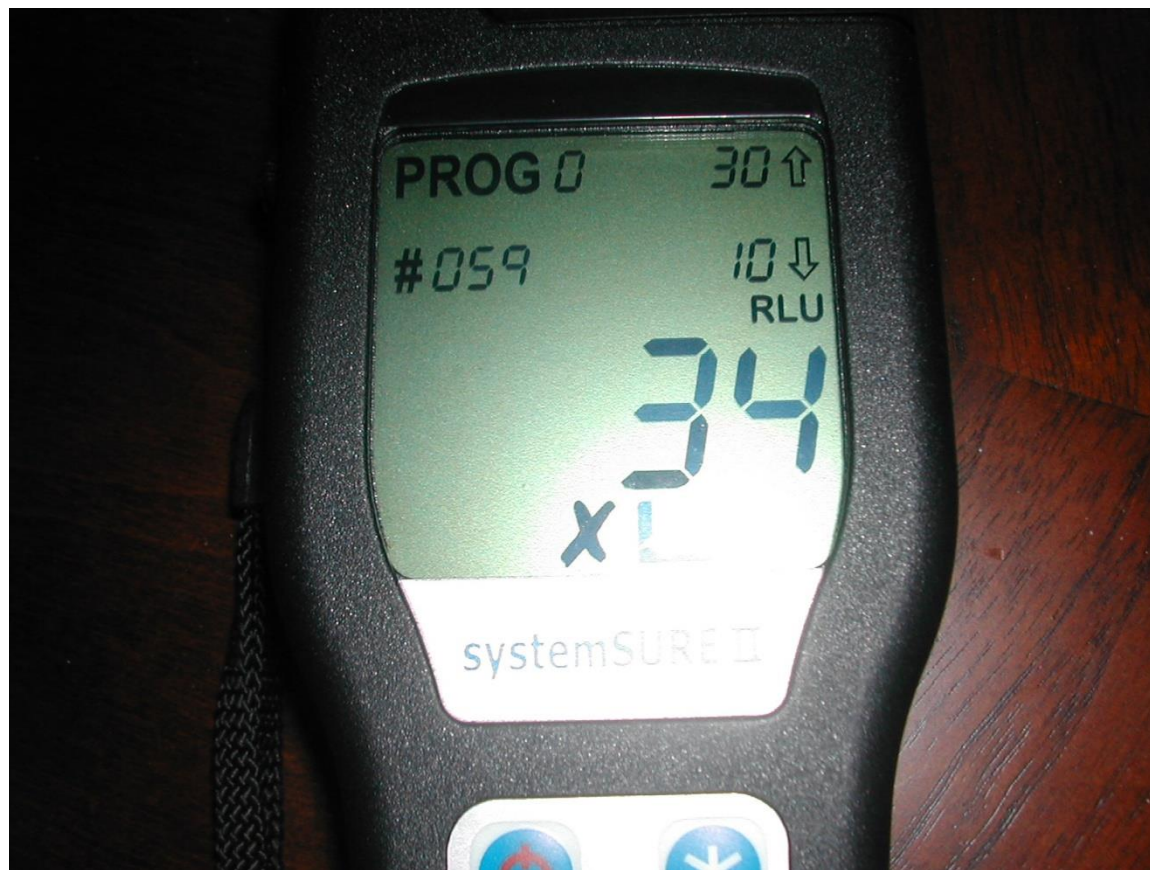
Contamination Count 34

Initial count from top of dresser in bedroom was 89. After 9 days count was 34.
